Miscellaneous Paper SL-98-1
January 1998

Investigation of Concrete from I-20 Near Monroe, Louisiana

by G. Sam Wong

Final report

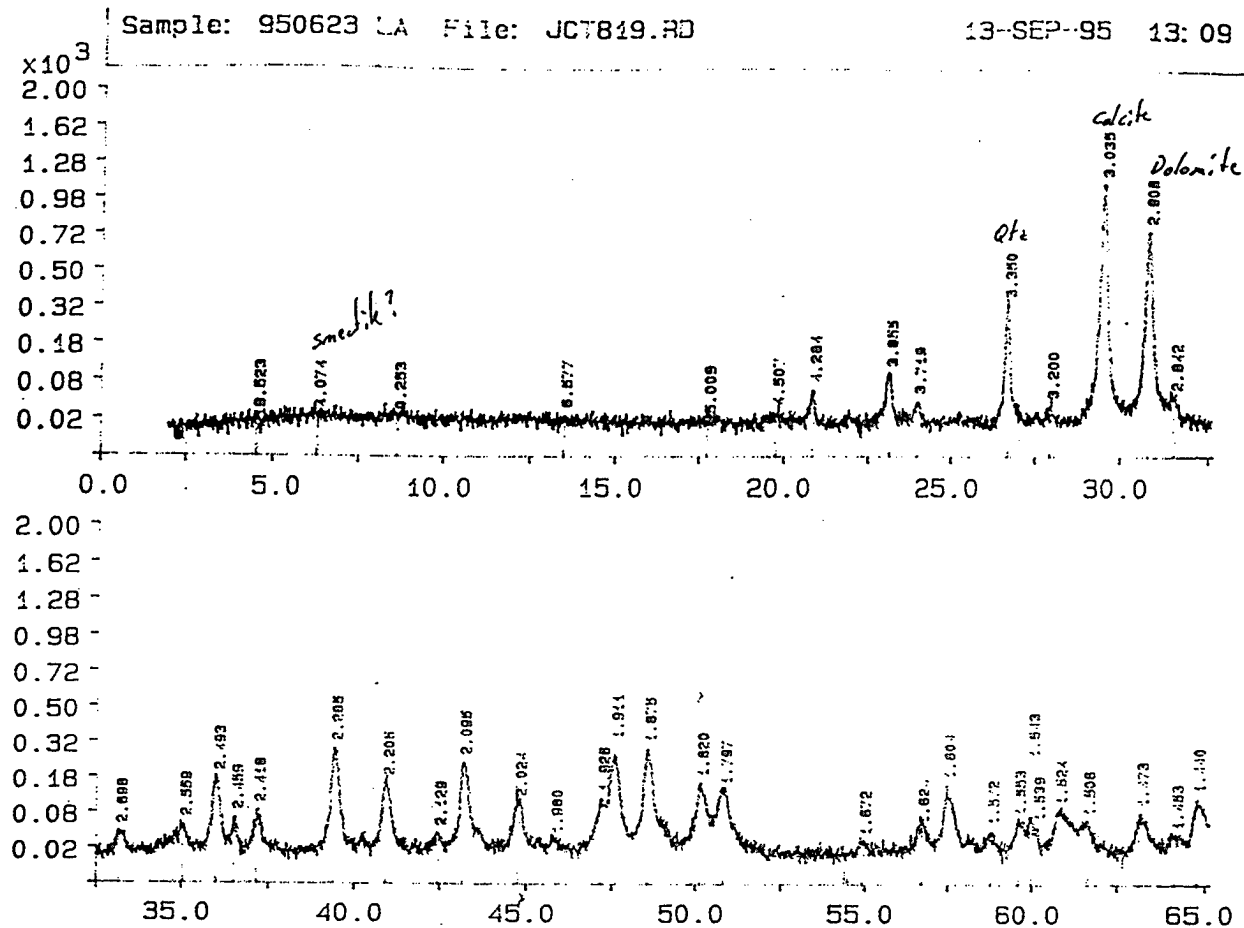
- a. 950623 - This core was cut along its entire length to expose the interior concrete. A near-surface vertical crack was associated with subsurface dark-gray coarse-aggregate particles with prominent reaction rims. These particles showed some interior cracks. X-ray diffraction examination of one particle indicated that the particle was composed of a fine-grained dolomitic limestone containing some quartz and clay, as shown in Figure 16. Some interior, randomly oriented incipient cracks were also observed associated with dark-gray coarse-aggregate particles with reaction rims, as illustrated in Figure A1, Appendix A. These cracks were located in the lower portion of the core.

Figure 16. X-ray diffraction pattern of reactive coarse-aggregate particle from core 950623

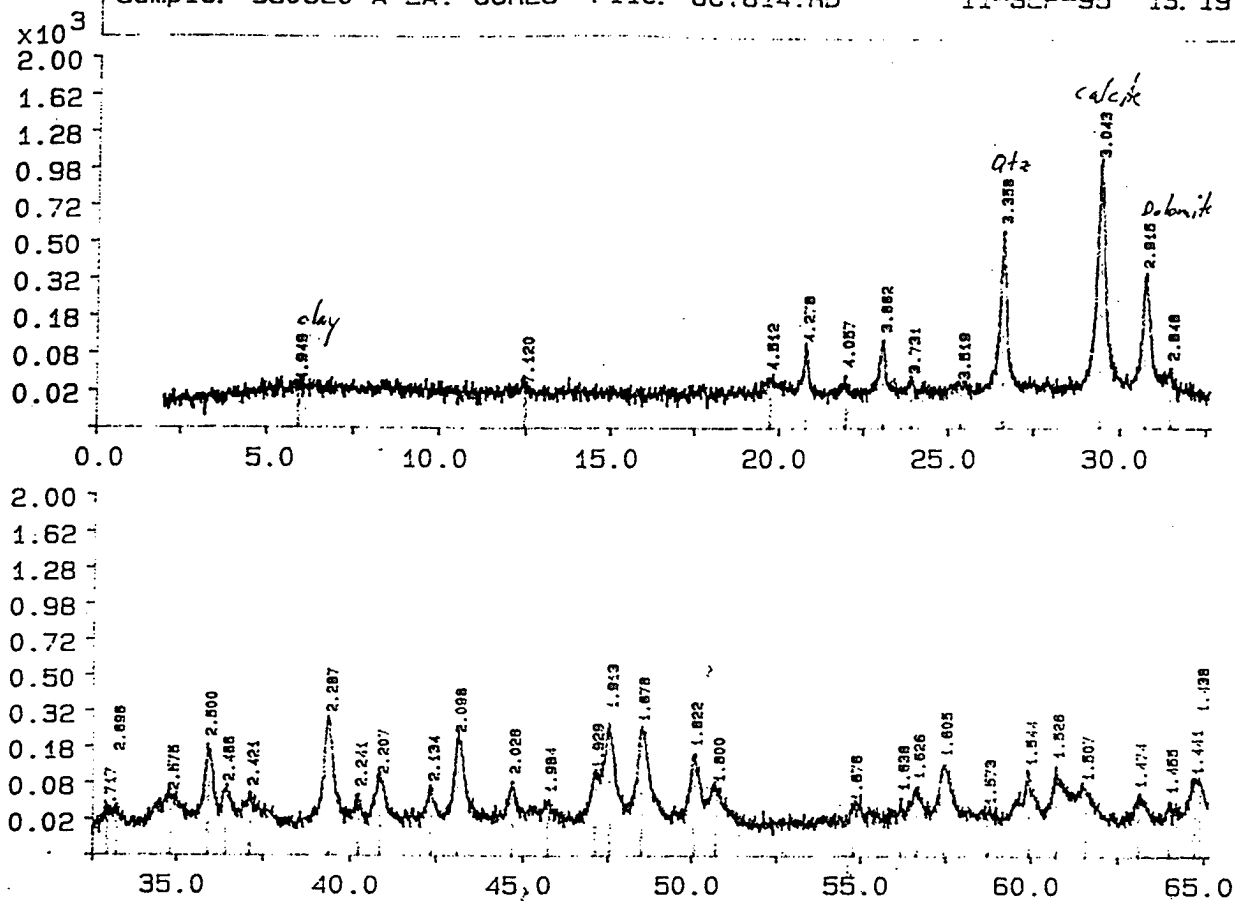
- f. 950620 - The core was cracked throughout its length. The cracks were randomly oriented. There were numerous dark-gray limestone coarse-aggregate particles with dark reaction rims. The rims exhibited radial cracks that extended into the paste. Aggregate particles with these rims were dolomitic limestone containing quartz and clay. X-ray diffraction patterns are presented in Figures 18 and 19. Figure A6, Appendix A, shows the appearance of these aggregate particles.

Figure 18. X-ray diffraction pattern of reactive coarse-aggregate particle #A from core 950620

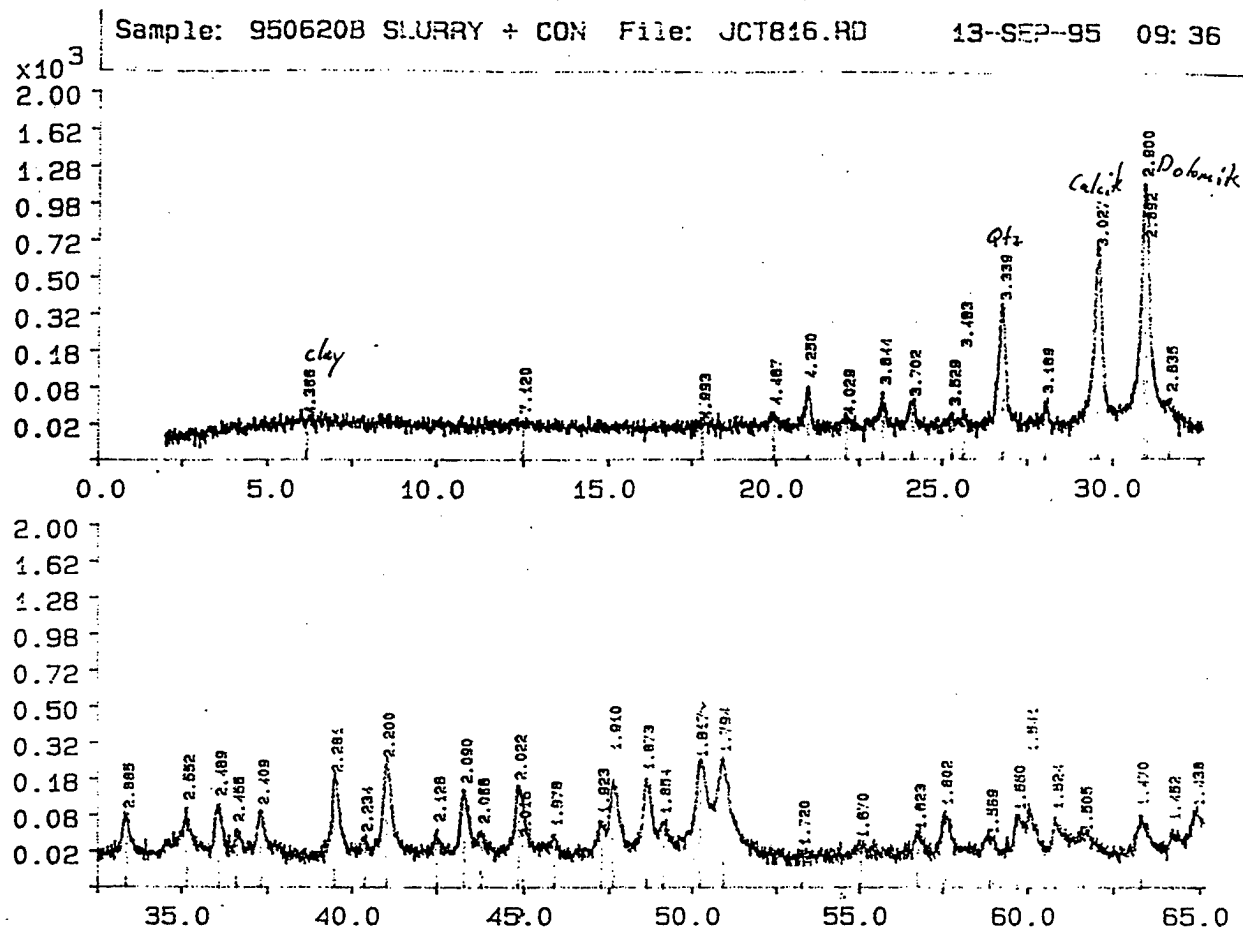
Figure 19. X-ray diffraction pattern of reactive coarse-aggregate particle #B from core 950620.

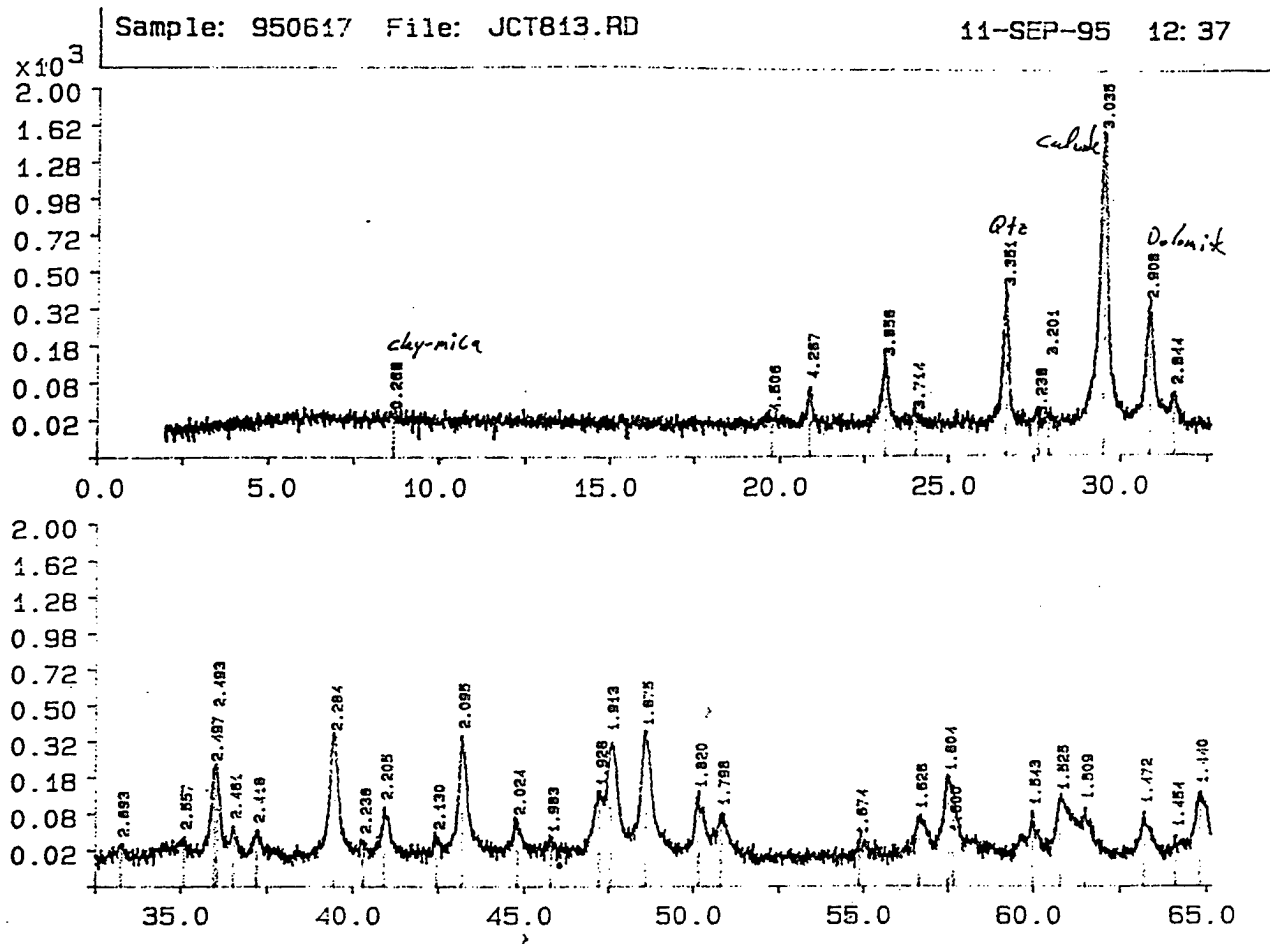
- h. 950617 - This sample consisted of rubble. The core had broken into fragments during the coring process. One large piece was impregnated using an epoxy resin and then cut open for examination. The concrete was highly fractured (Figure A8, Appendix A). There were numerous dark-gray limestone coarse-aggregate particles. Cracks were mostly associated with the larger coarse-aggregate particles. The associated dark-gray coarse-aggregate particles were dolomitic limestone containing some quartz as well as illite (clay-mica). An X-ray diffraction chart showing the relative abundance of the calcite and dolomite is presented in Figure 20.

Figure 20. X-ray diffraction pattern of reactive coarse-aggregate particle from core 950617

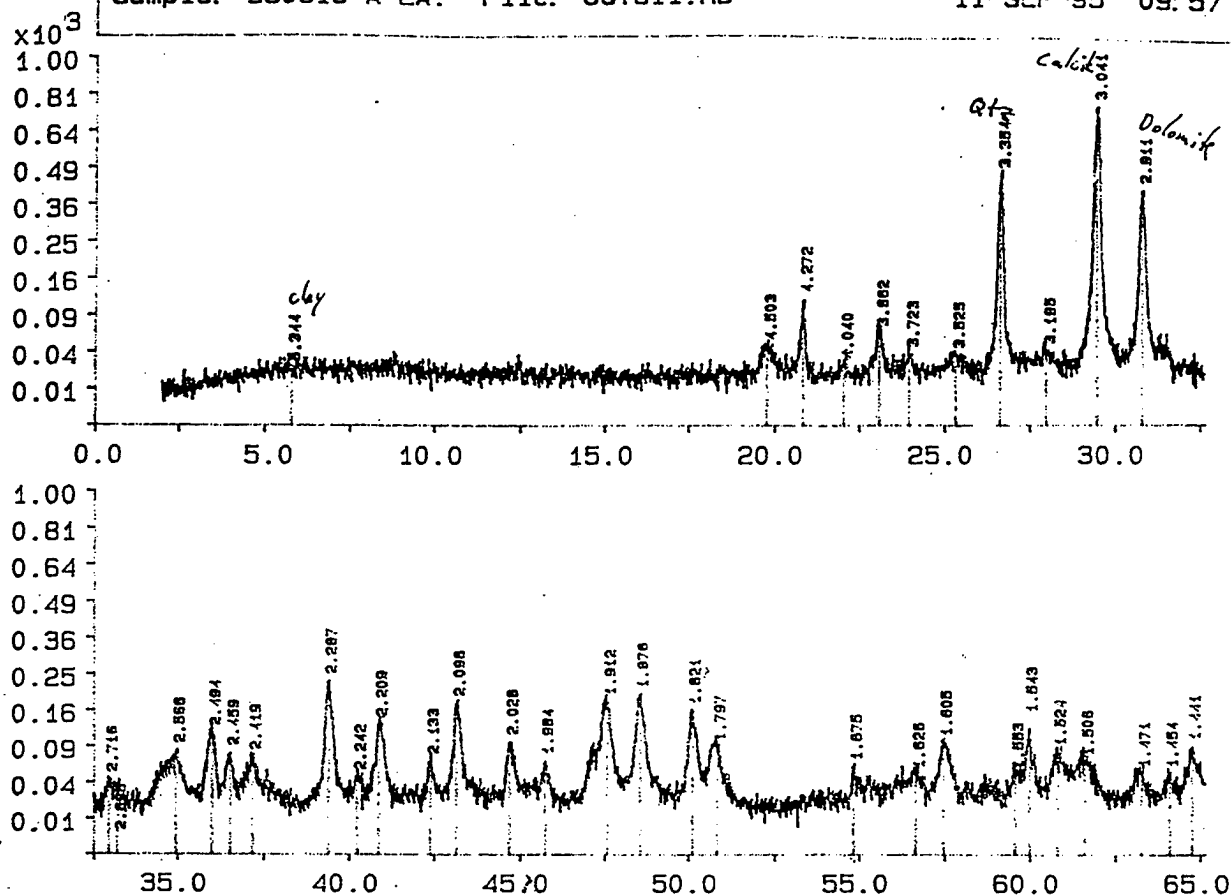
- j.* 950616 - The surface cracking was light. However, the interior concrete showed an extensive crack system. A vertical crack extended several inches into the interior concrete going through coarse-aggregate particles as well as around them. The vertical cracks intersected horizontal and diagonal cracks (Figures A9a and A9b, Appendix A). The majority of the cracks were associated with cracked dark-gray fine-grained limestone coarse-aggregate particles. Two particles examined by X-ray diffraction were dolomitic limestone with acid-insoluble materials consisting of quartz and clays. Figures 21 and 22 illustrate the relative abundance of the carbonate phases.

Figure 21. X-ray diffraction pattern of reactive coarse-aggregate particle #A from core 950616

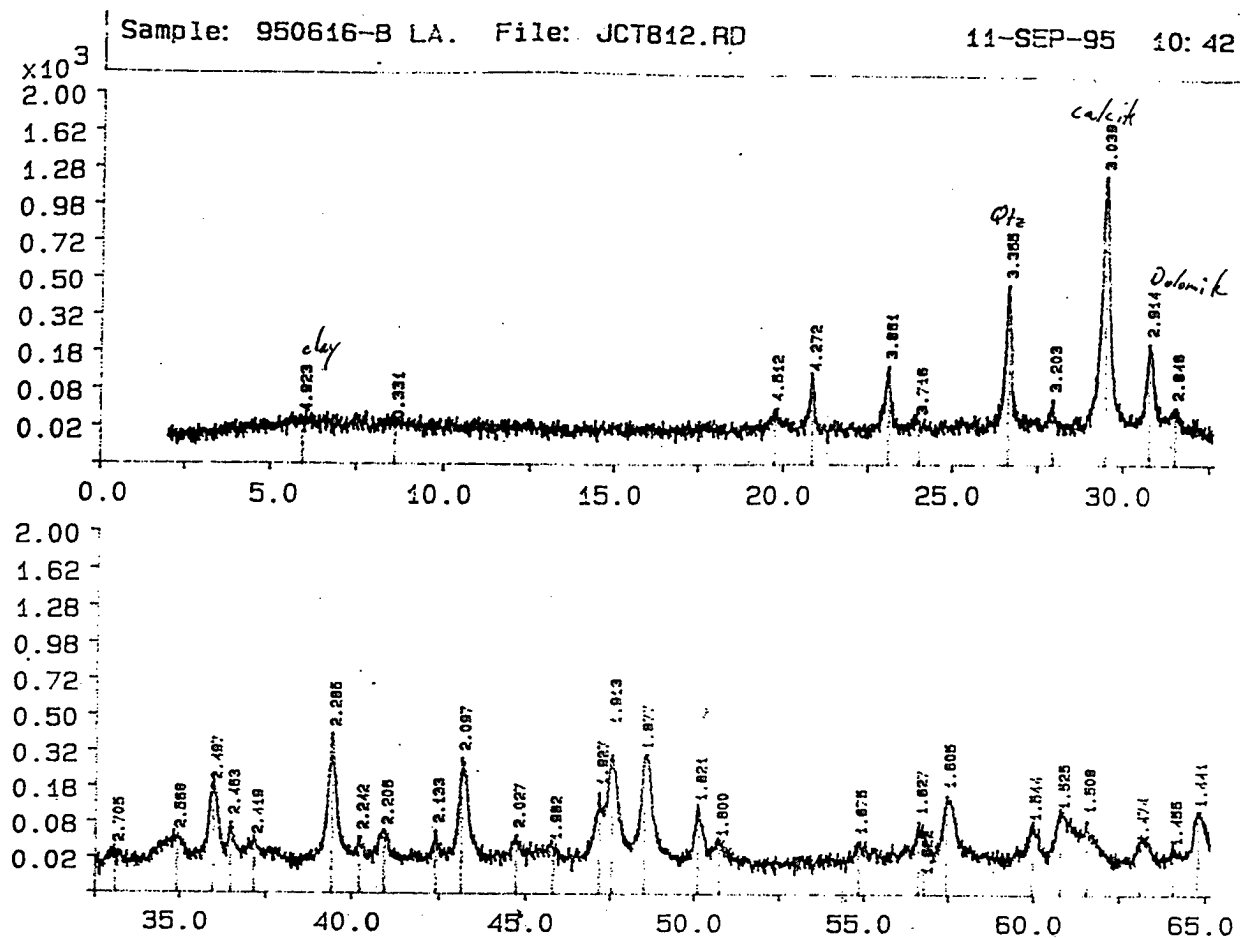
Figure 22. X-ray diffraction pattern of reactive coarse-aggregate particle #B from core 950616

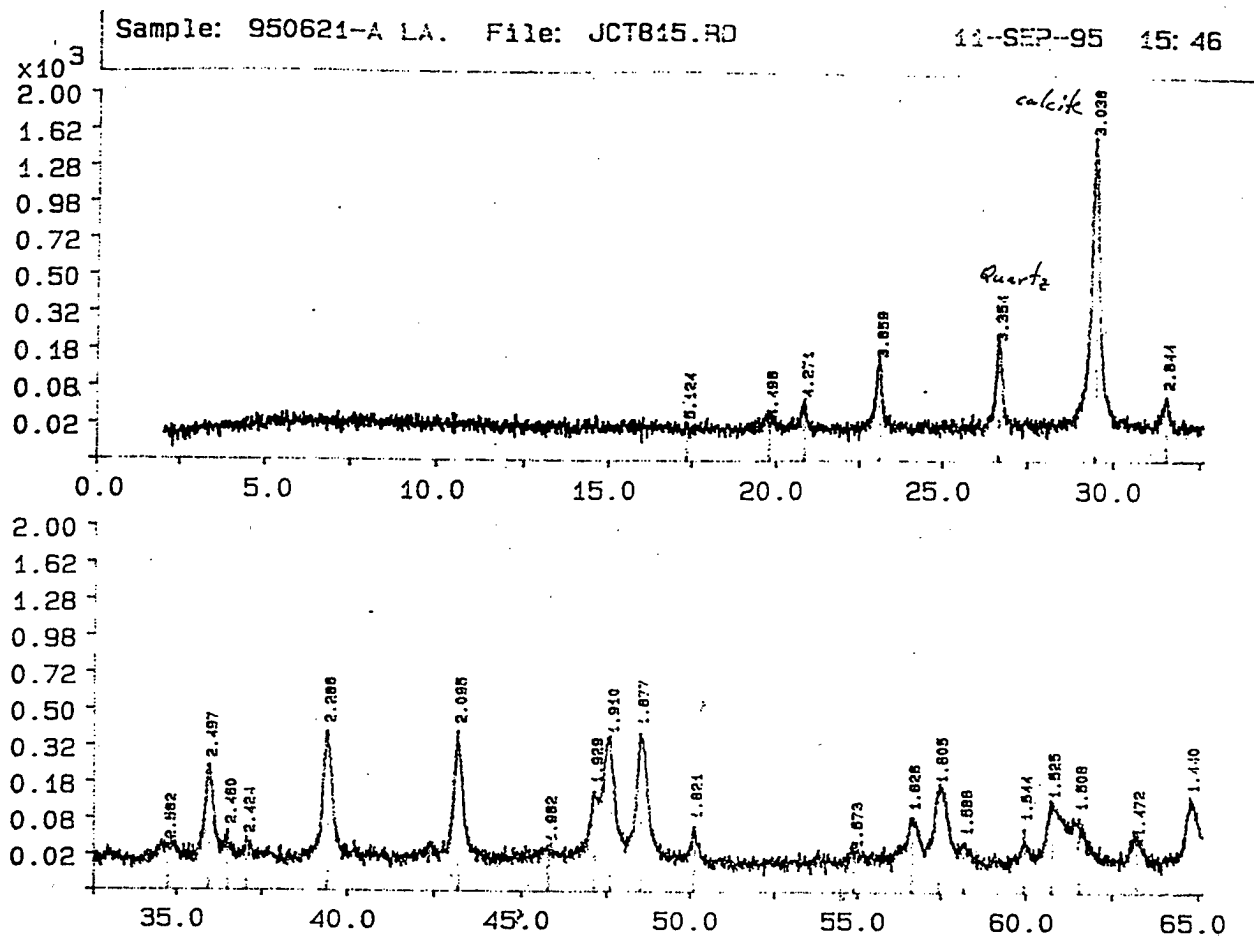
Figure 23. X-ray diffraction pattern of non-expansive reactive coarse-aggregate particle #A from core 950621

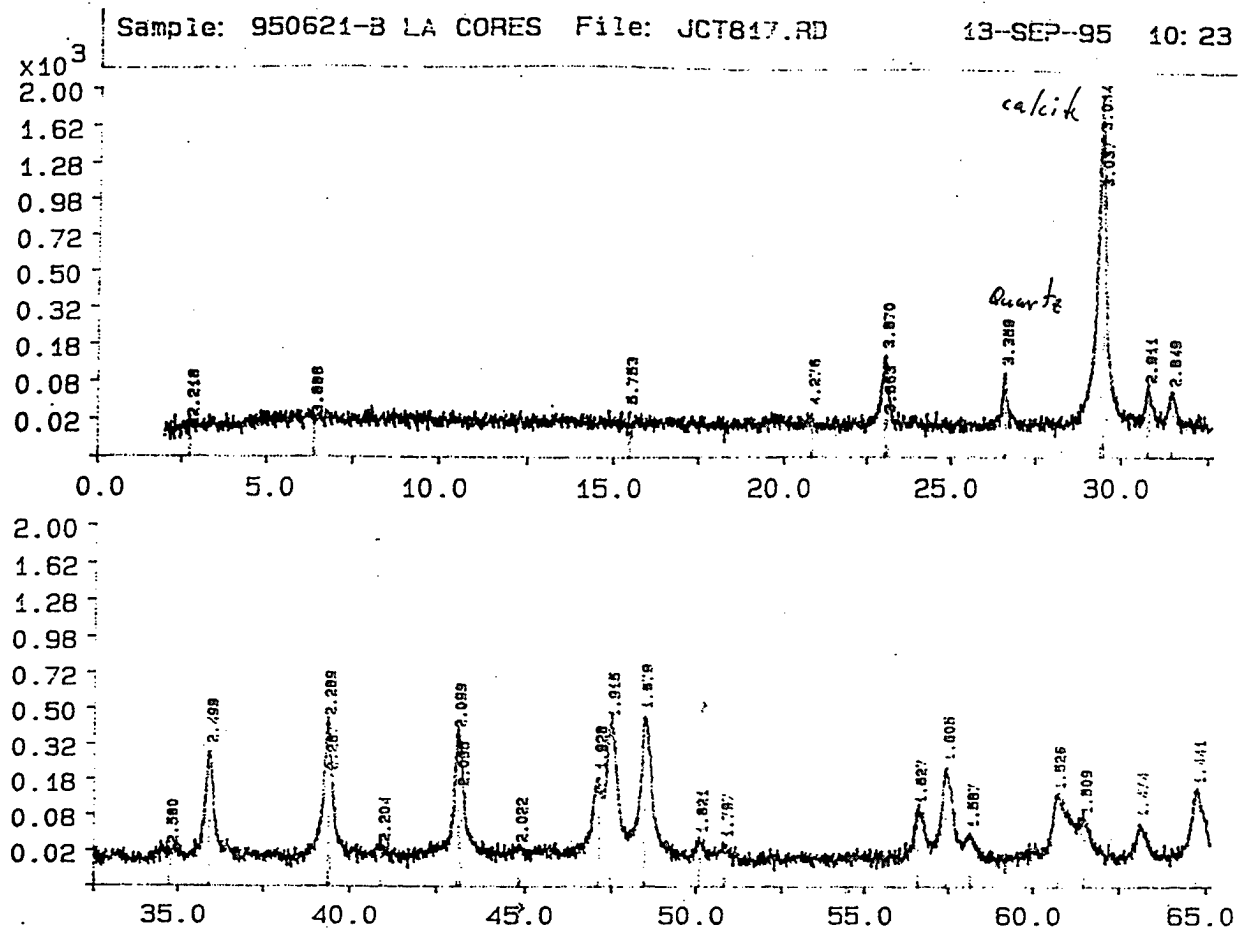
- m.* 950621 - This concrete had some hairline cracks at the surface. One crack penetrated into the interior concrete approximately 1 in. (25.4 mm) and terminated in the paste. The upper portion of the concrete consisted of lighter colored limestone coarse-aggregate particles. The lower portion of the core contained numerous dark-limestone coarse-aggregate particles with dark reaction rims. Some cracks associated with these limestone aggregate particles are shown in Figure A12, Appendix A. The X-ray diffraction pattern of aggregate particle #A, a dark-gray particle with a prominent dark reaction rim, showed it to be pure limestone, as shown in Figure 23. Light-colored brownish limestone with a reaction rim (particle #B) was pure limestone, as identified in Figure 24. The dark-gray particle

Figure 24. X-ray diffraction pattern of non-expansive reactive coarse-aggregate particle #B from core 950621

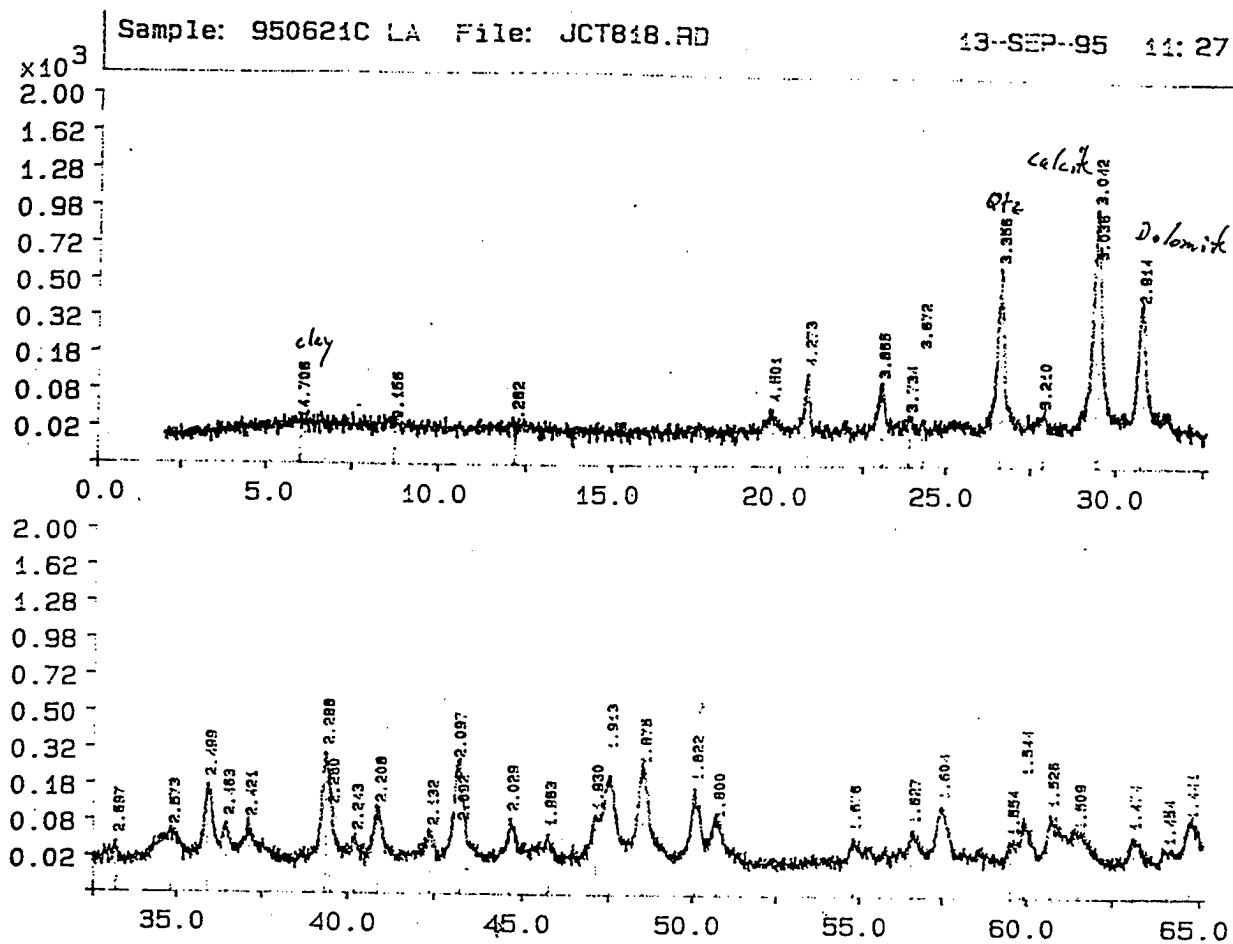
with a prominent reaction rim (Figure A12, Appendix A) (particle #C) was a fine-grained dolomitic limestone also containing insoluble material including clays and quartz (Figure 25). A thin section of a near-surface dark-gray fine-grained impure limestone coarse-aggregate particle showed a rim on this aggregate and micro cracks in the rim propagating into the paste. Etching of coarse-aggregate particle using dilute hydrochloric acid showed no relief in the rim area; i.e., the rim was neither more nor less acid soluble than the unaltered rock.

Figure 25. X-ray diffraction pattern of expansive reactive coarse-aggregate particle #C from core 950621

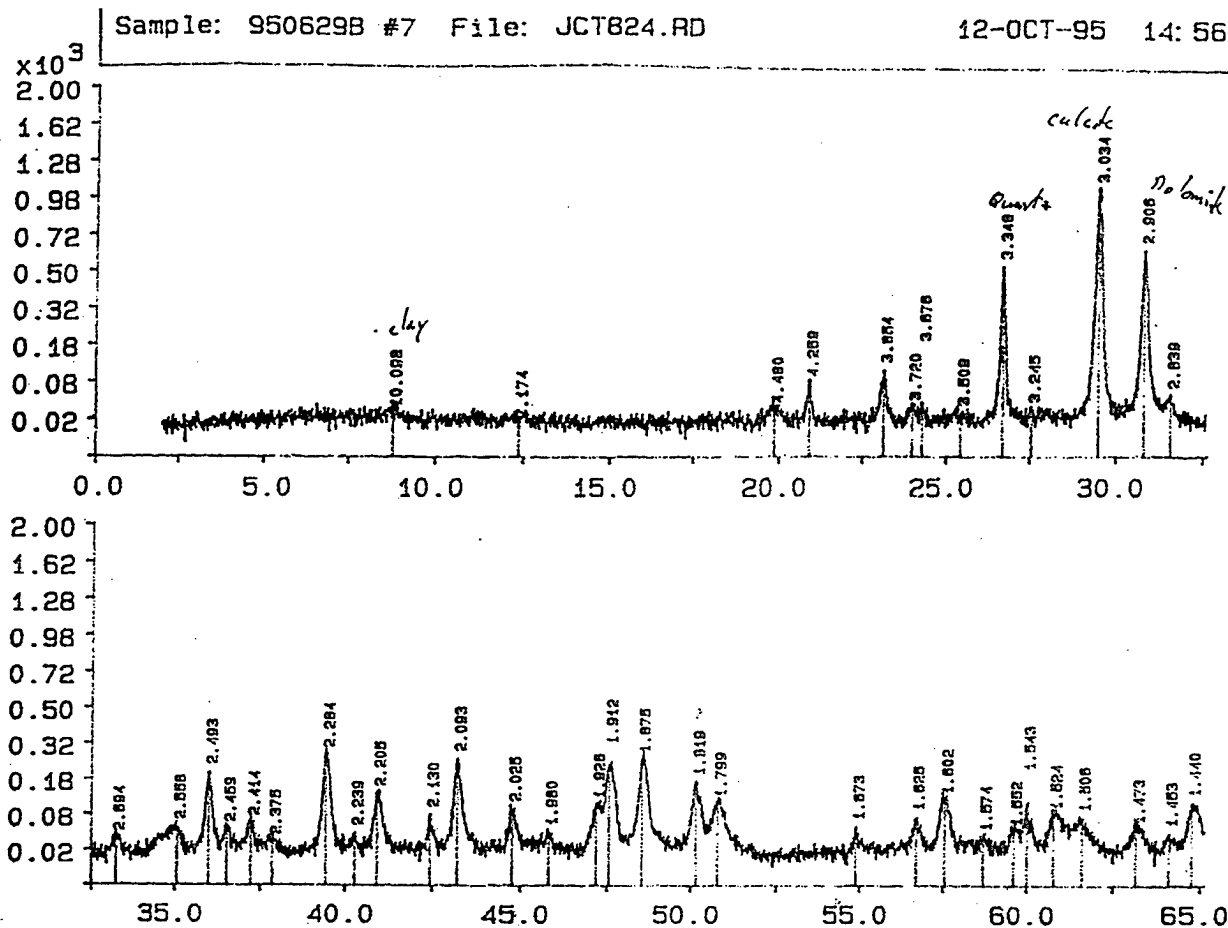
Rock-cylinder expansion measurements indicated that some of the aggregate particles were highly reactive when stored in sodium hydroxide in accordance with ASTM C 586. Figures 28 and 29 show expansion data up to 64 days. The specimens were immersed in water for 7 days and showed no change in length. Specimens from both limestone samples included aggregate materials that expanded significantly. Sample 950629 showed immediate expansion and rose to above 3 percent at 35 days; measurements were terminated for these particular specimens as they began to fall apart. Sample 950630 yielded specimens that expanded to above 0.4 percent in 64 days in sodium hydroxide. Analysis of a highly expansive particle in 950629 (particle B) indicated the sample to be composed of dolomitic limestone containing some quartz and clay. No reaction products were detected by X-ray diffraction analysis, as shown in Figure 26.

Figure 26. X-ray diffraction pattern of highly reactive coarse-aggregate particle #B from limestone sample 950629 after treatment in sodium hydroxide
